| | <p align="center"><b>Cobrimento, Corrosão e Durabilidade</b></p> <p align="center">Primeiras pesquisas sobre corrosão das armaduras<br/>no concreto armado - 1912 - USA</p> | <p>Prof.. Eduardo<br/>C. S. Thomaz<br/>Notas de aula</p> |

1 - Artigo da Revista Brasileira de Engenharia / 1926, sobre Cobrimento, Corrosão e Durabilidade no Concreto Armado.

**ACTION OF THE SALTS IN ALKALI WATER AND SEA WATER ON CEMENTS , do Bureau of Standards / USA / 1912**

**ACTION OF THE SALTS IN ALKALI WATER  
AND SEA WATER ON CEMENTS**

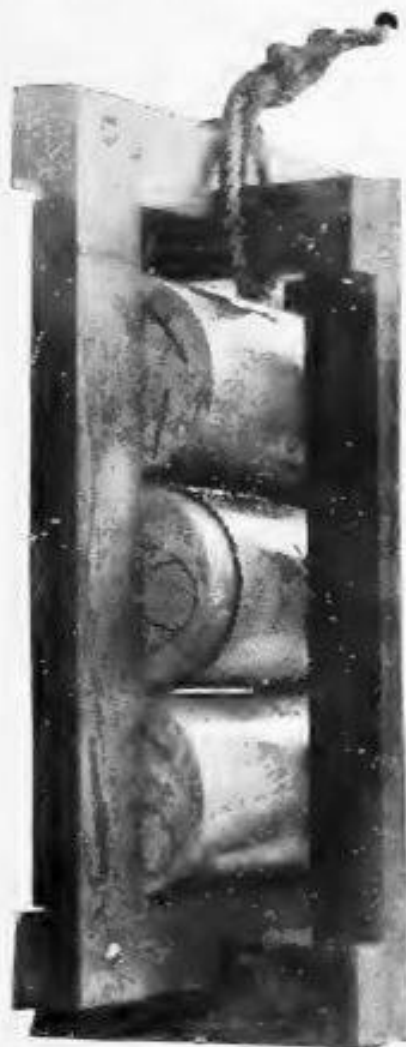
Fig. 19.—*Crate with concrete test pieces  
before placing in sea water*

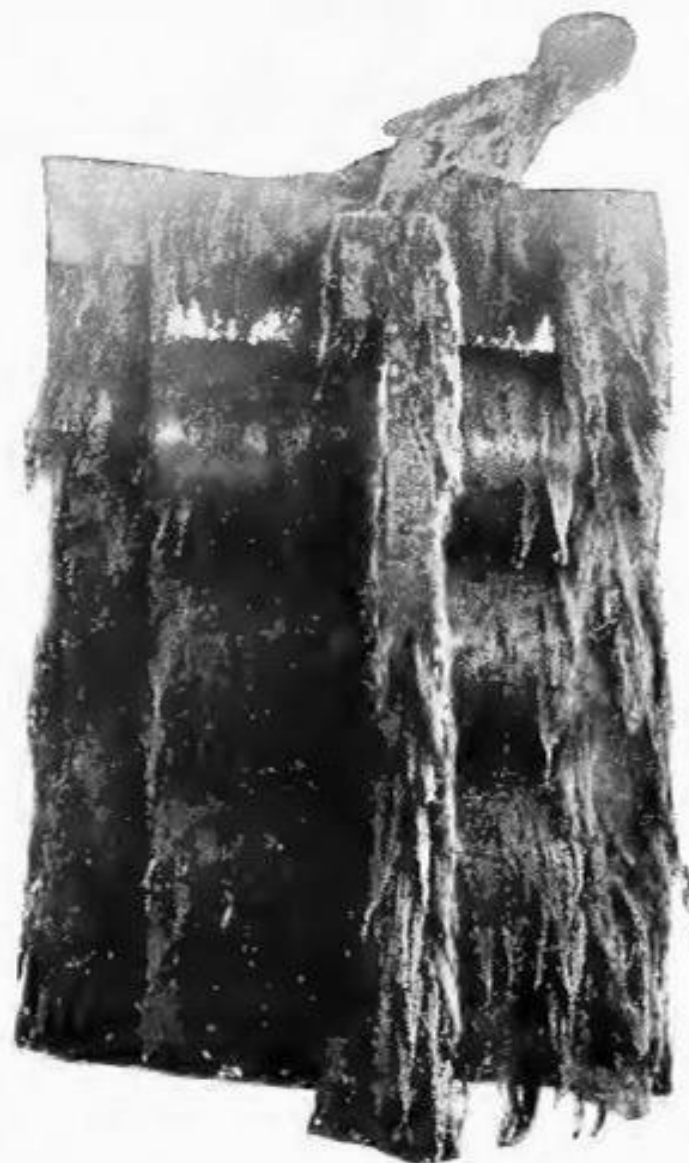
Fig. 20.—*Crate with concrete test pieces after  
storage in sea water*

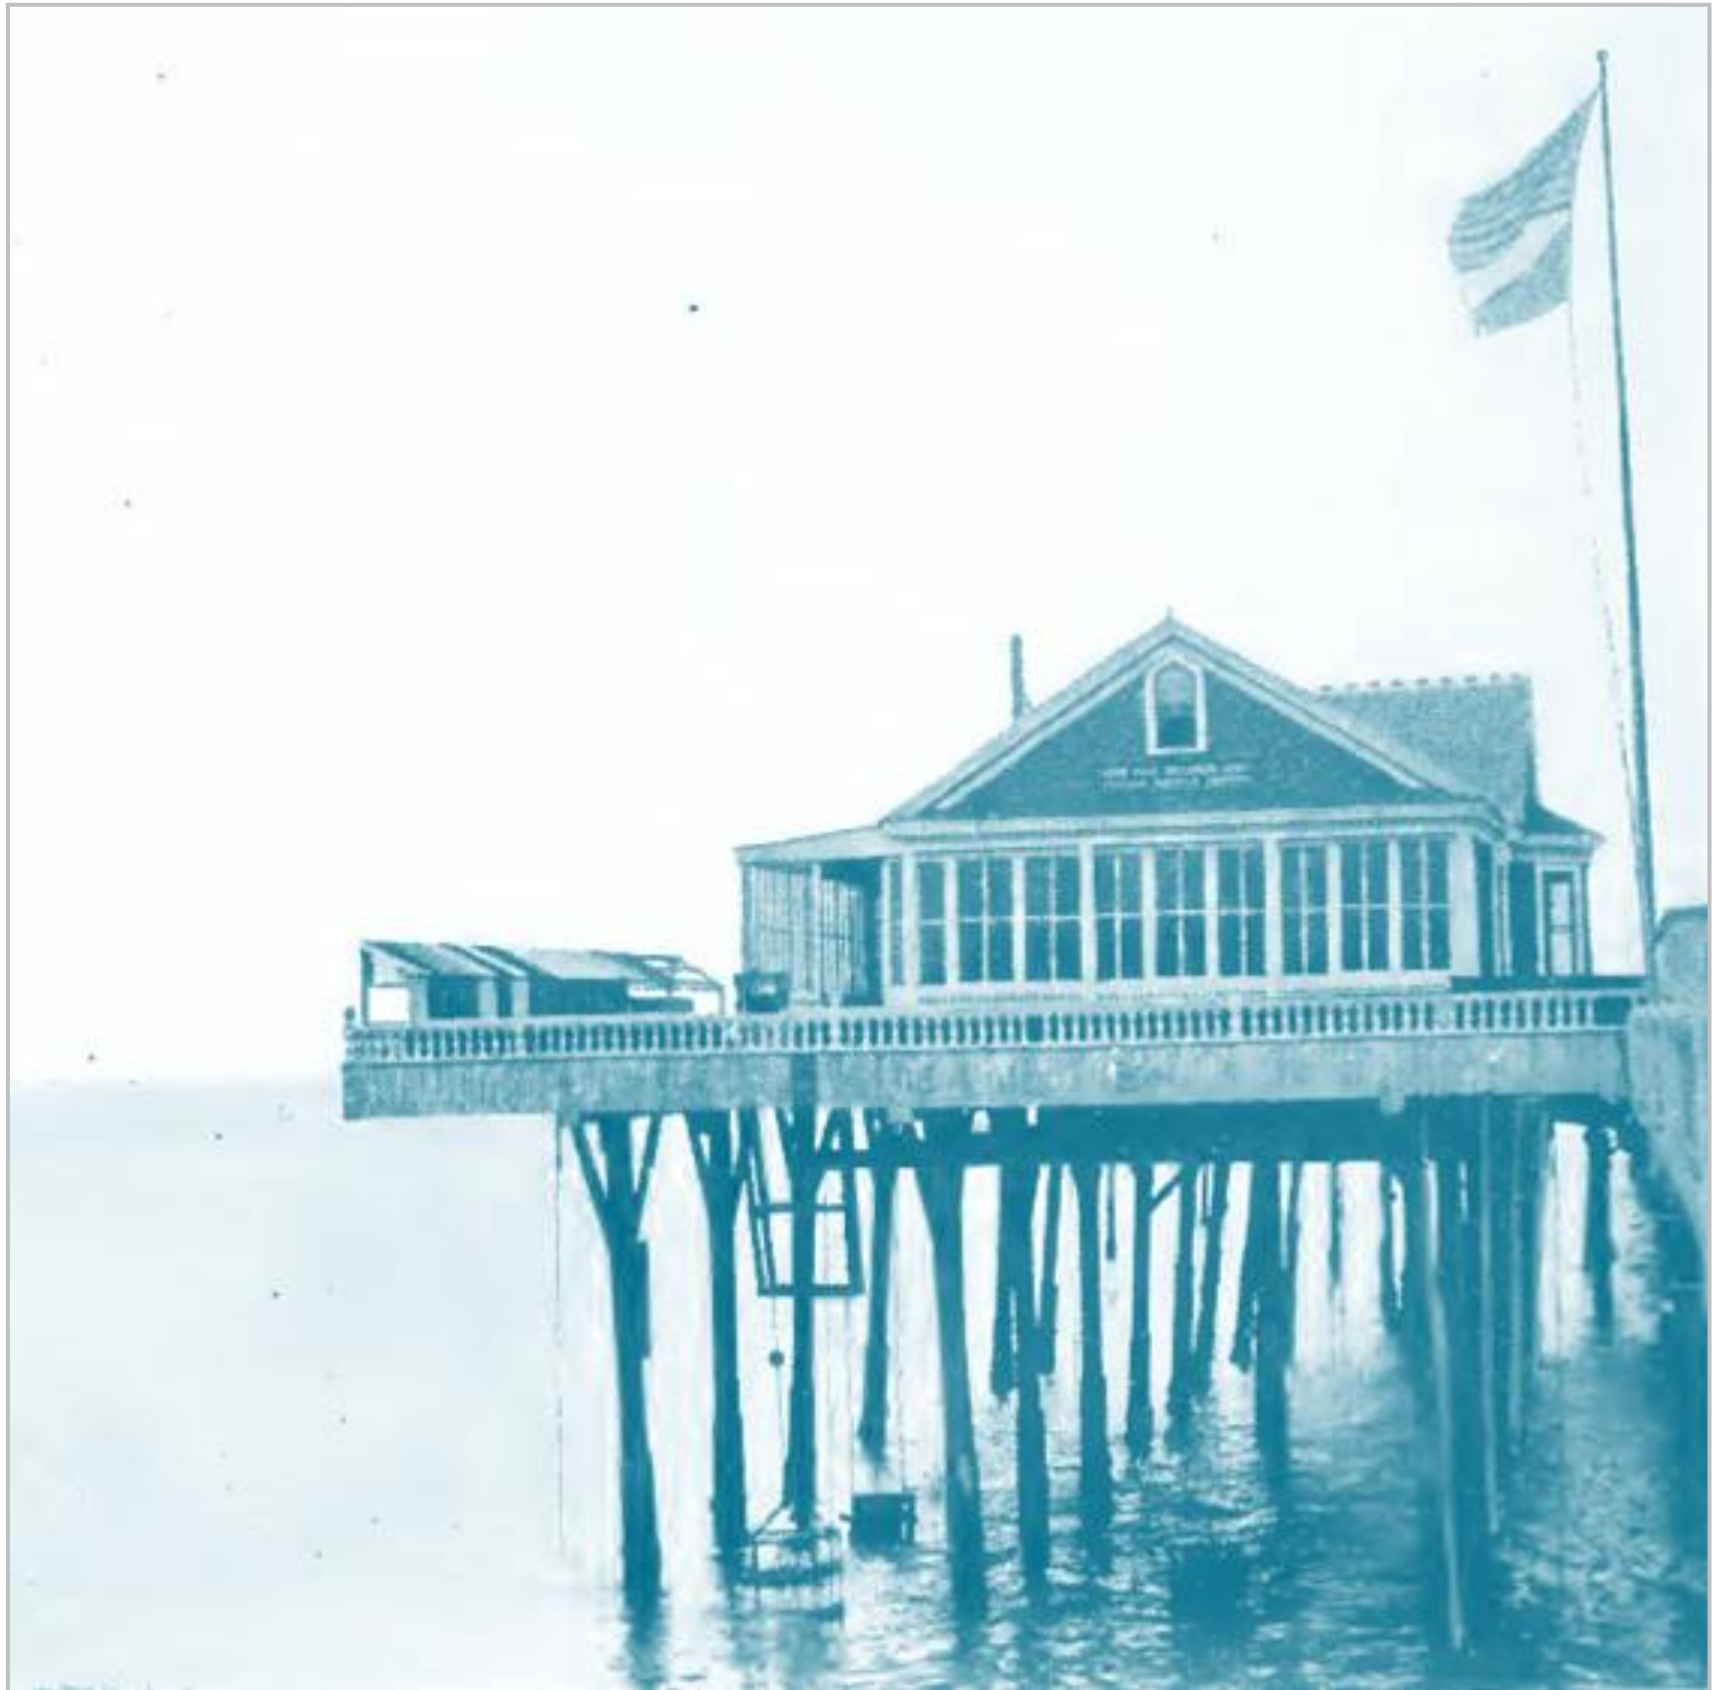
Fig. 17.—*Laboratory at Atlantic City, N. J.*

## LABORATÓRIO NO MAR

TABLE 23  
Corrosion Tests of Metal Embedded in Concrete Cylinders Immersed in Sea Water  
[Exposed metal to be placed as per Fig. 39c]

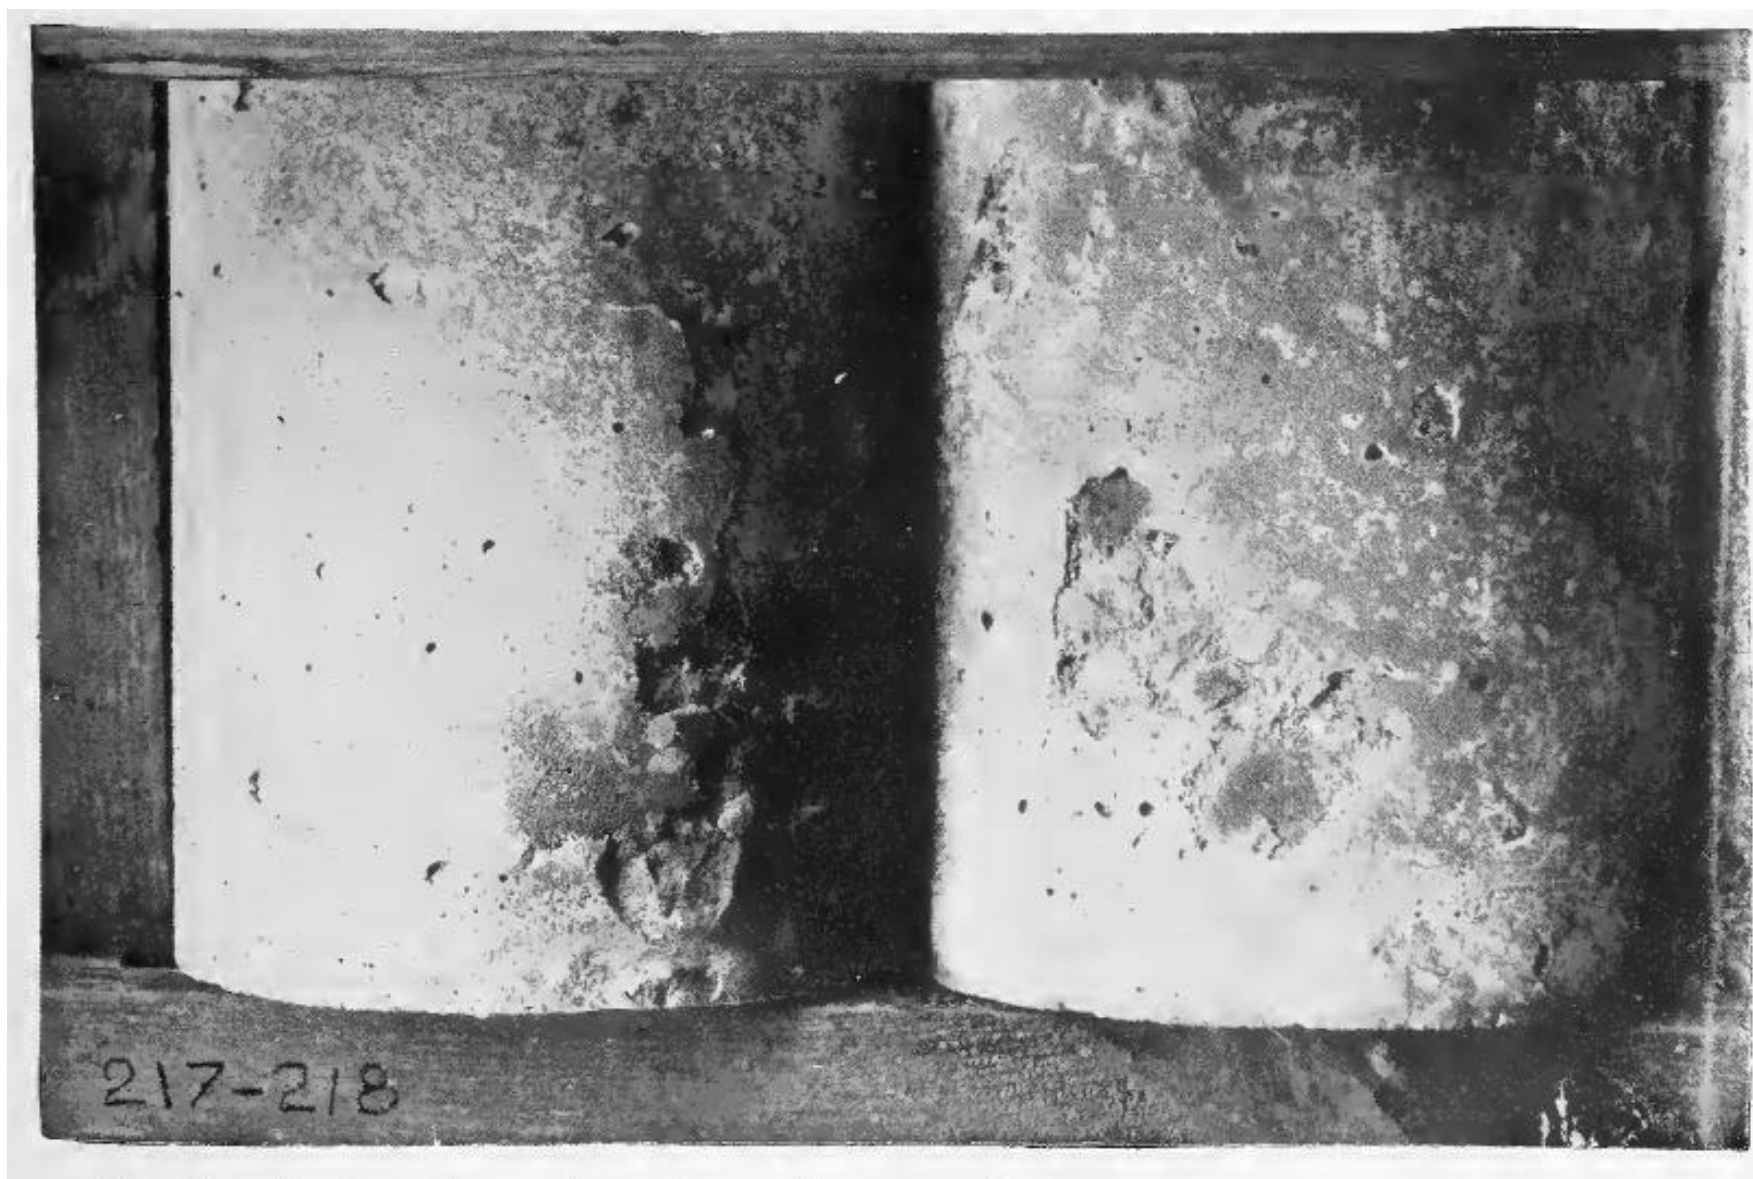
Fig. 25.—Portions of concrete specimens after one year's exposure to sea water, showing cracked surface and layer flaking off
