Corrosão das Armaduras em Infraestruturas de Pontes de Concreto Armado *Richard F. Stratfull - 1973*	Prof. Eduardo C. S. Thomaz Notas de aula

ENVIRONMENTAL INFLUENCE
ON THE CORROSION OF REINFORCING STEEL
IN CONCRETE BRIDGE SUBSTRUCTURES

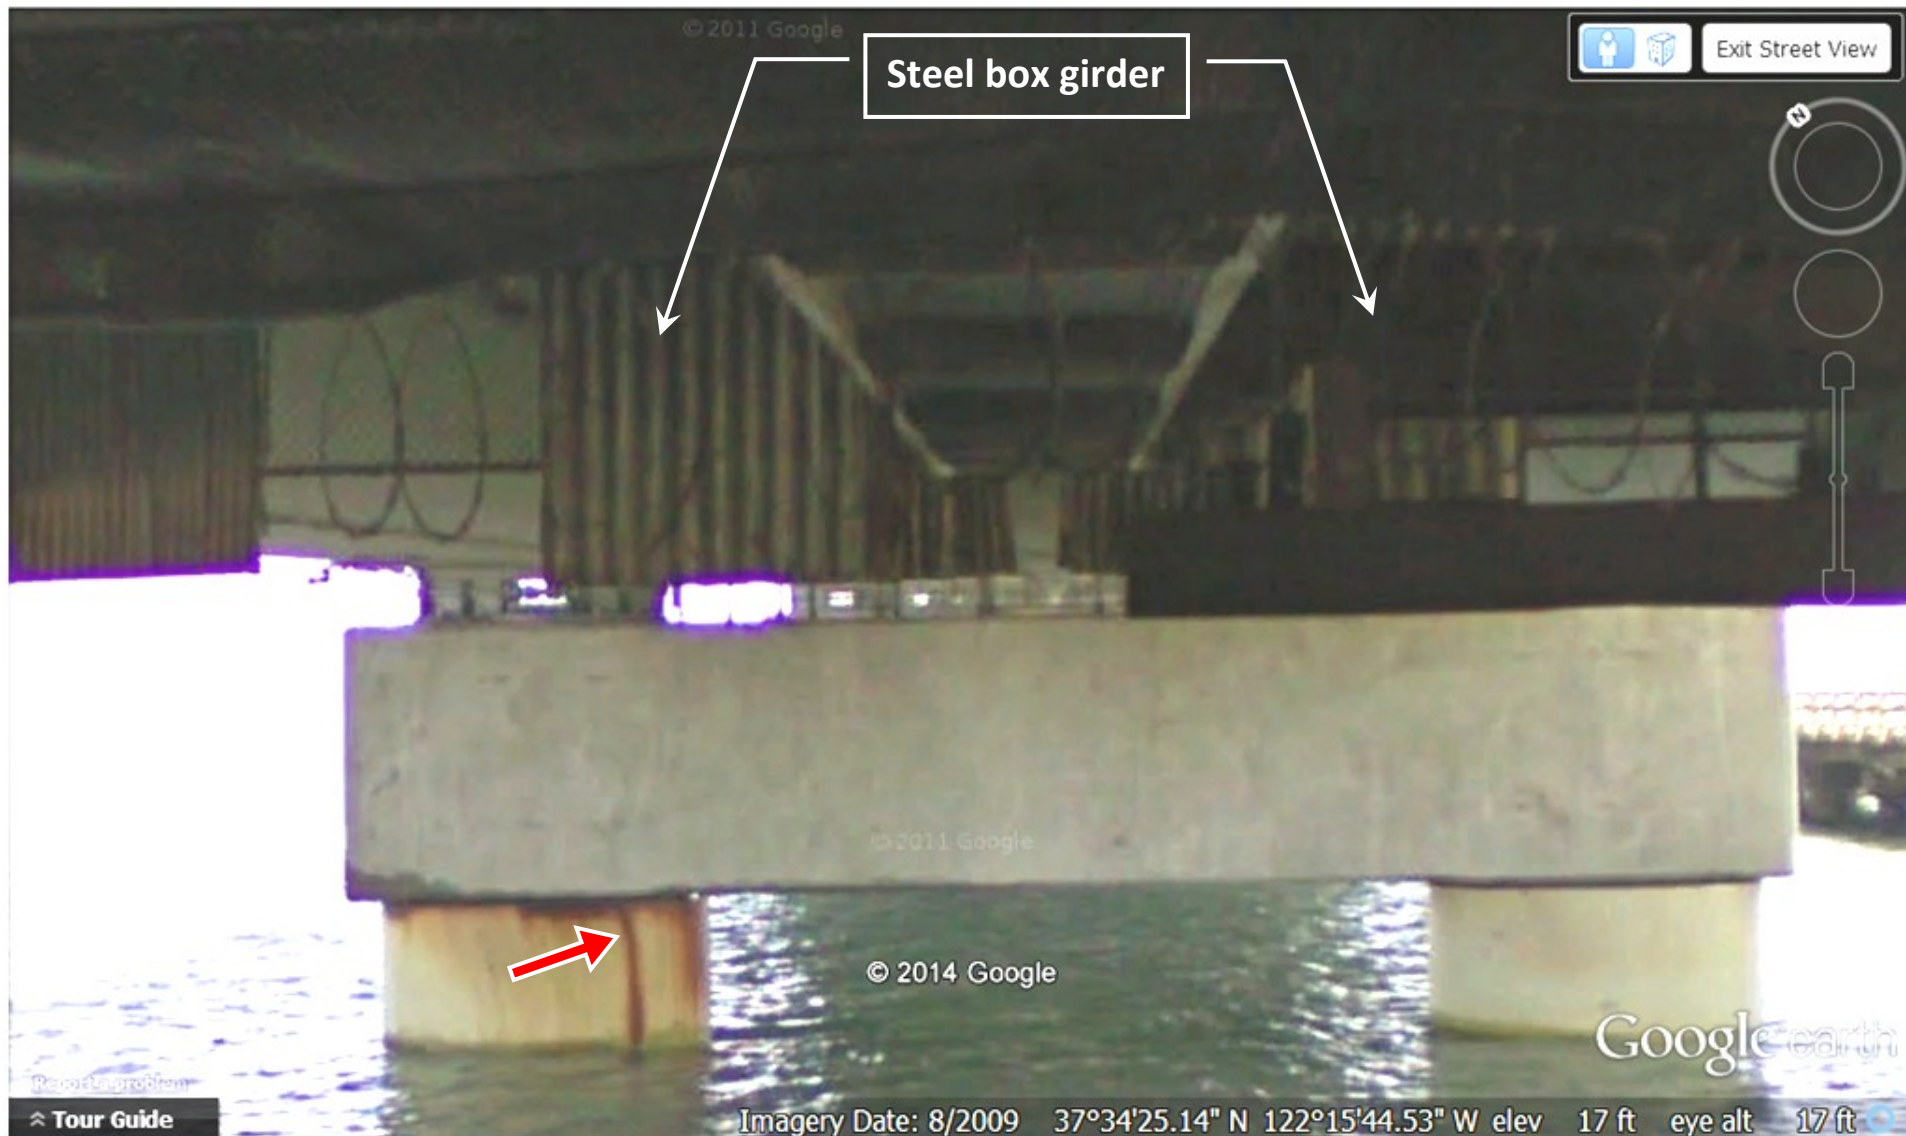
1967 - San Mateo-Hayward Bridge - GOOGLE

Sinaisde corrosão : " Rust stains on the surface of the concrete "

O escorrimento de ferrugem ($Fe_2O_3.H_2O$) é proveniente da corrosão da armadura dentro do concreto.
Vicente Gentil - *CORROSÃO* - Editora LTC - 1996

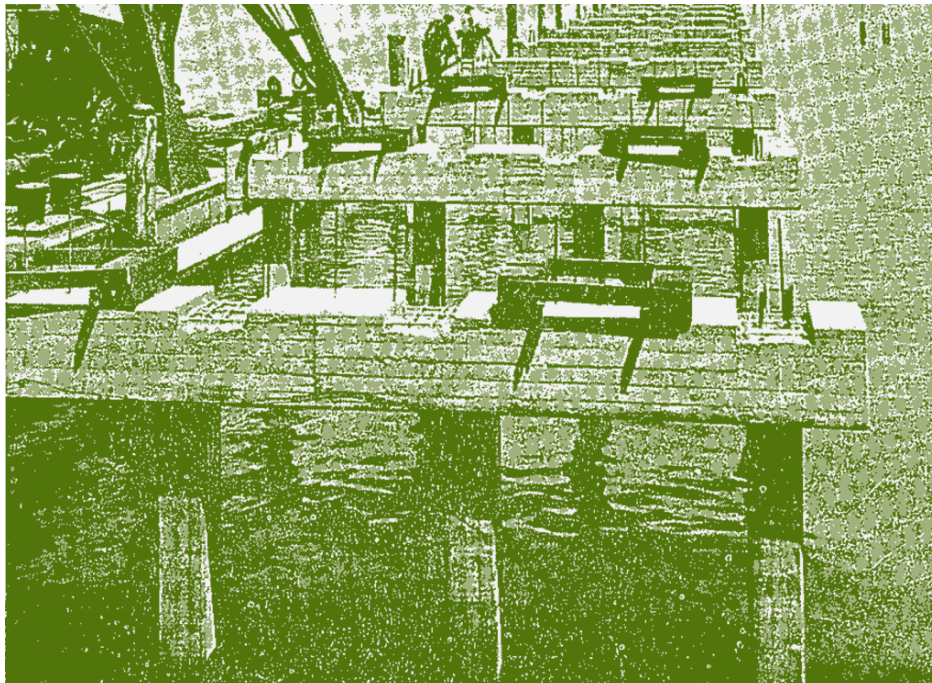
" The concrete of the San Mateo-Hayward Bridge, a structure 7 miles in length across San Francisco Bay, constructed in 1928-9 is severely cracked due to corrosion of reinforcing steel.

In the bar bents sampled it appears that the concrete was mixed with a water-cement ratio that was too high to assure durability under the conditions of exposure.

Salts that have concentrated in the concrete have lowered the pH and have increased electrical conductivity. As a result the concrete, in its present condition at least, affords less than normal protection against corrosion of the reinforcement.

Precast mortar blocks, installed to support reinforcement above the bottom of beam forms, have very little bond with the adjacent concrete. Medium to severe corrosion has occurred more frequently in the vicinity of the blocks than elsewhere along the bars.

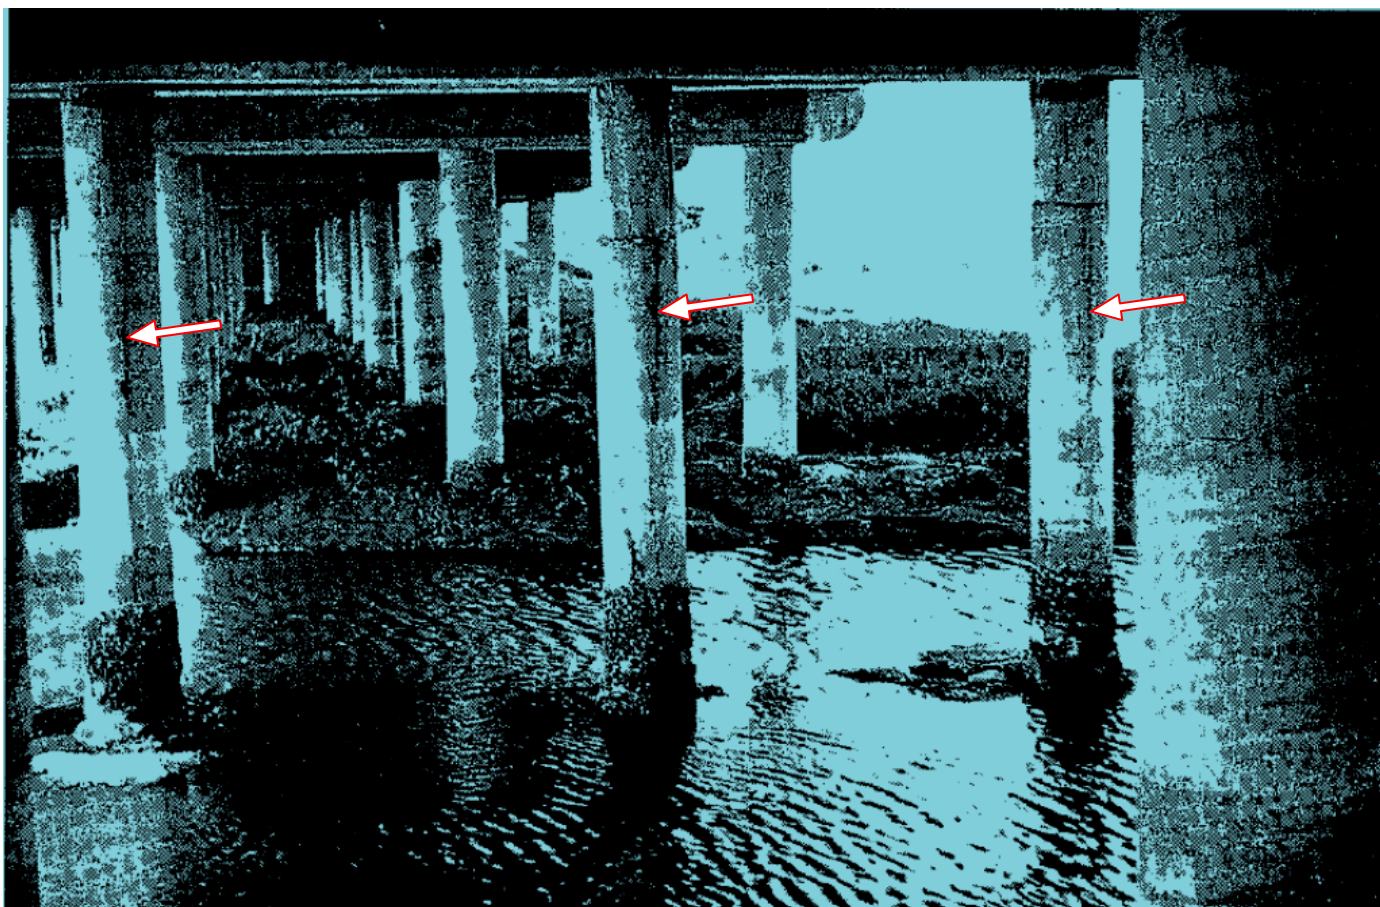
Photograph 1

Vertical concrete cracking of 10 year old reinforced concrete bridge piles in tidal water near San Diego, California. Photo taken in 1962.

Photo 1 depicts the cracking of reinforced concrete piles in a 10 year old bridge exposed to tidal water near San Diego, California.

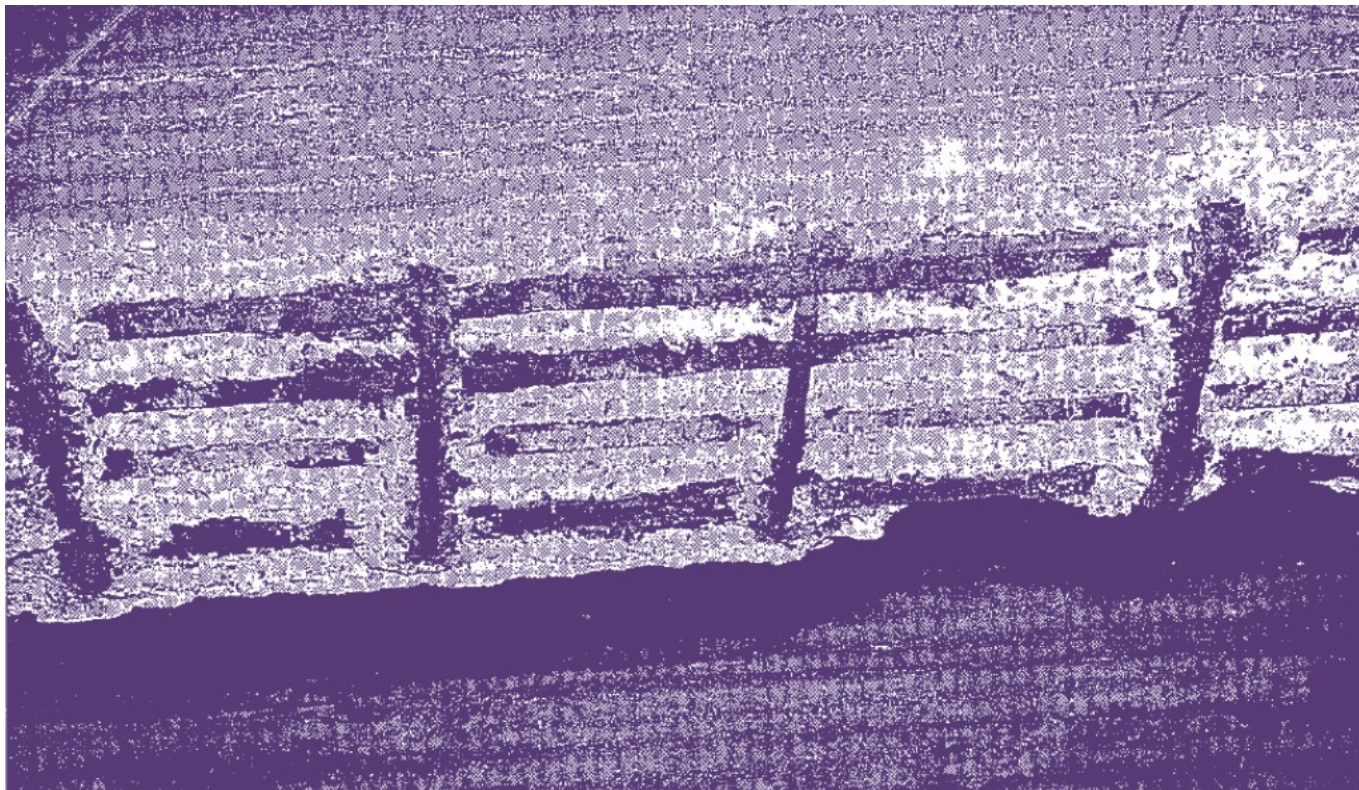
Photograph 2

Spalling of concrete in beam caused by the corrosion of reinforcing steel, San Francisco-Oakland Bay Bridge. Photo taken in 1962.

Photo 2 shows an area of advanced concrete spalling and the exposed reinforcing steel on the San Francisco-Oakland Bay Bridge.
