Corrosão das Armaduras na Infraestrutura de Pontes de Concreto Armado

ENVIRONMENTAL INFLUENCE
ON THE CORROSION OF REINFORCING STEEL
IN CONCRETE BRIDGE SUBSTRUCTURES

J. L. Beaton
and
R. F. Stratfull

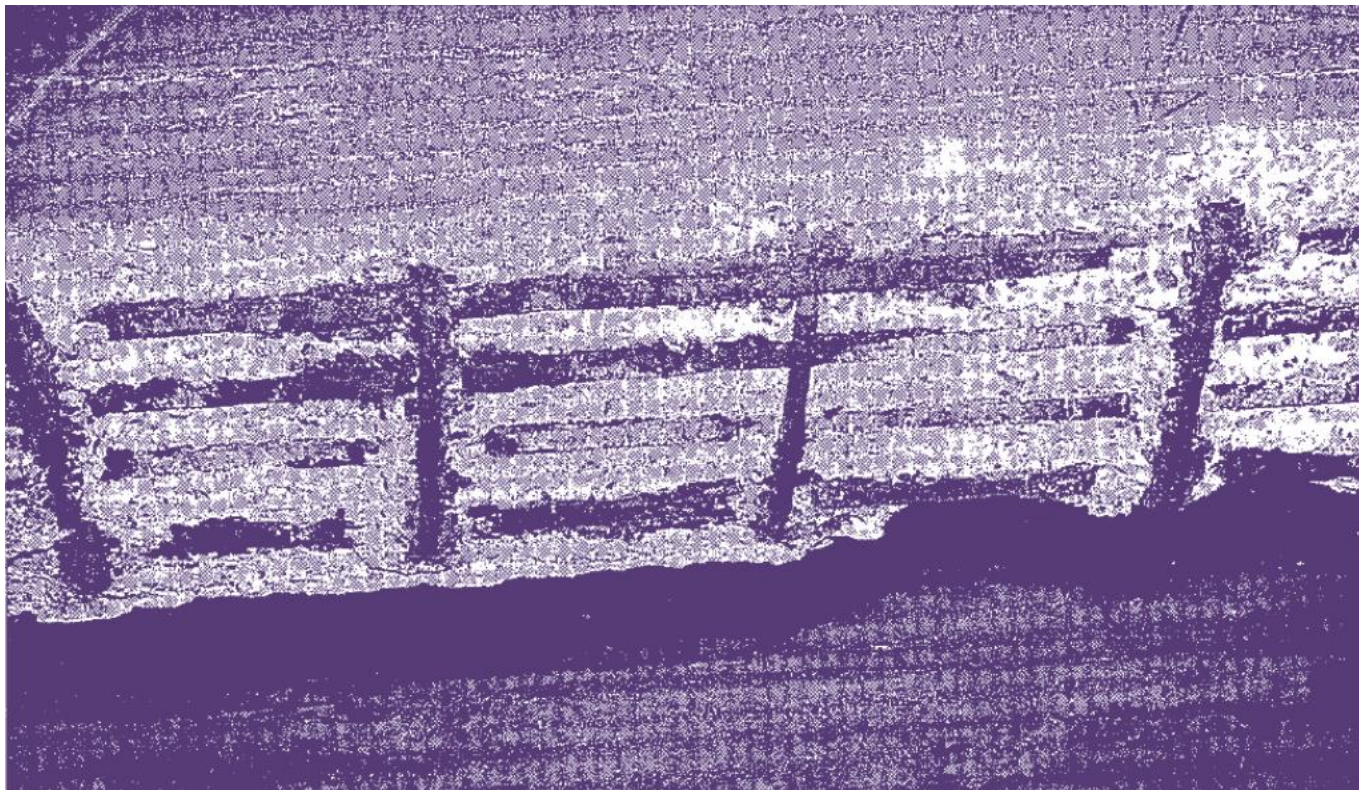
Photograph 2

Spalling of concrete in beam caused by the corrosion of
reinforcing steel, San Francisco-Oakland Bay Bridge.
Photo taken in 1962.

Photo 2 shows an area of advanced concrete spalling and the exposed reinforcing steel on the San Francisco-Oakland Bay Bridge.

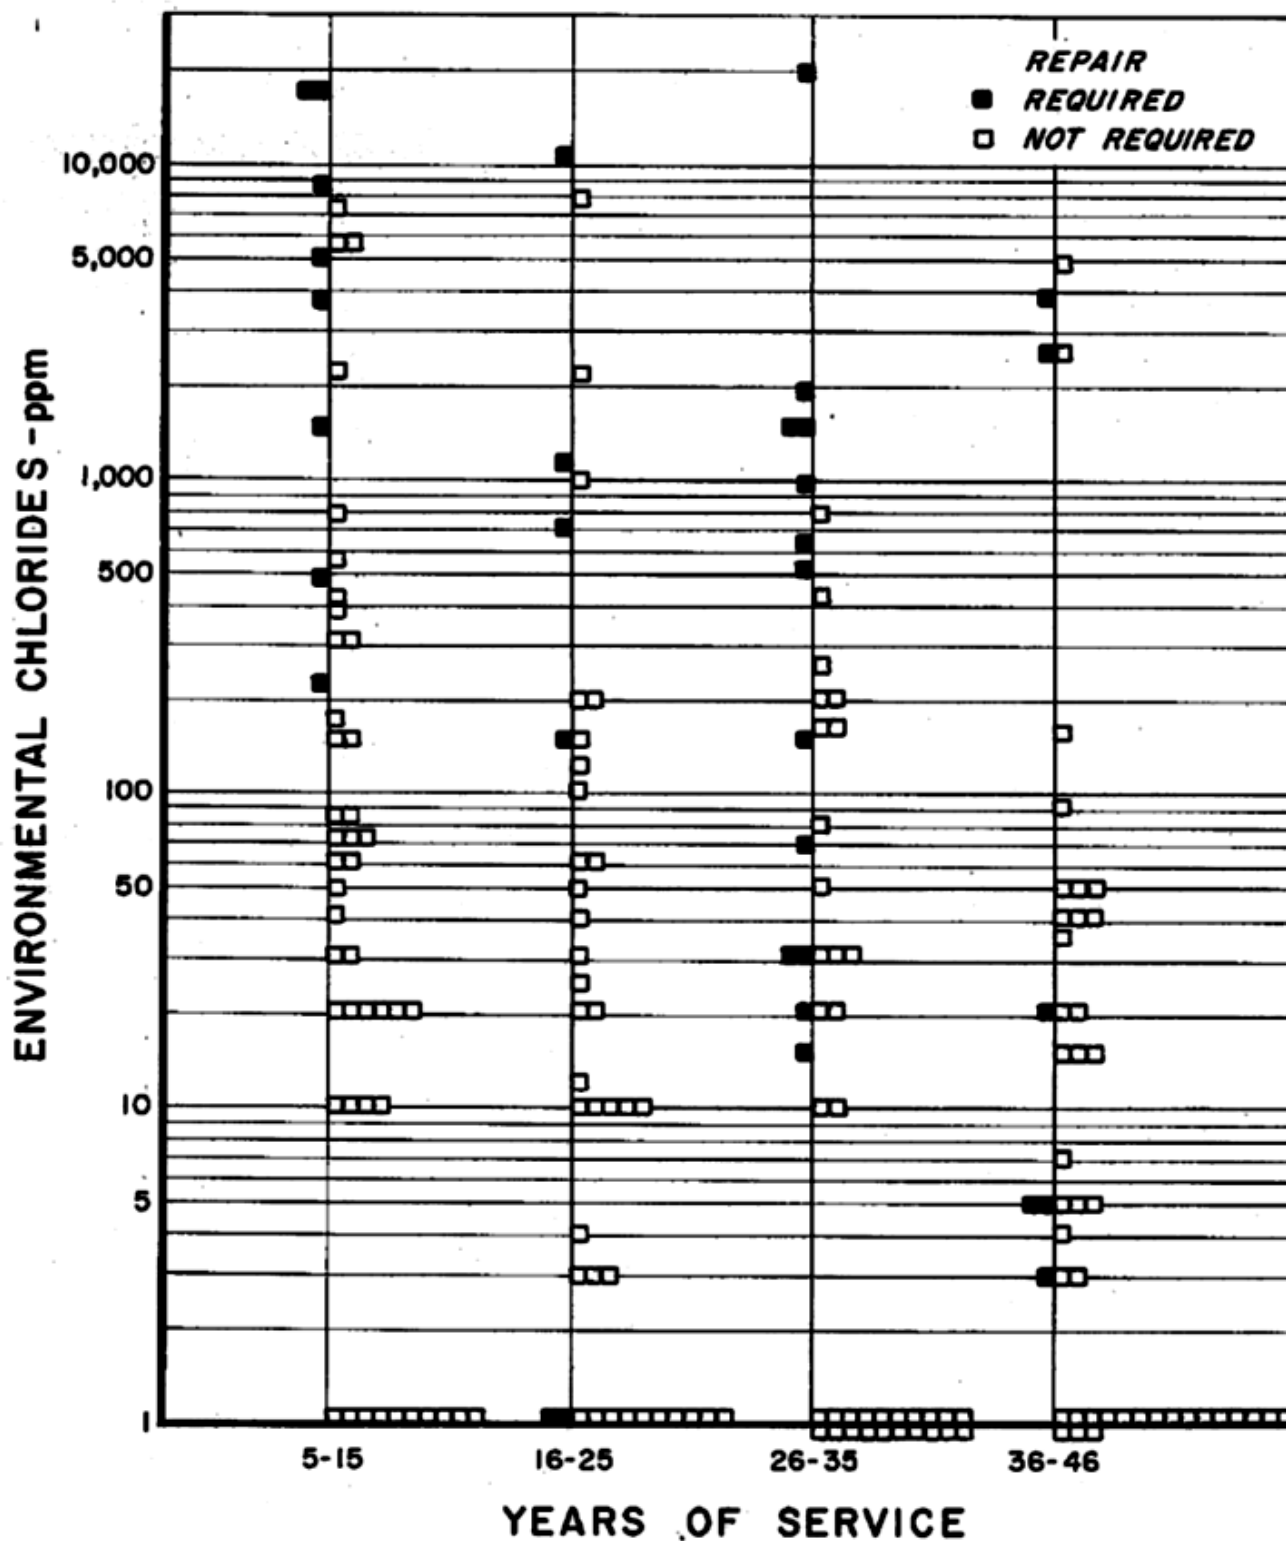
FIGURE 1

Figure 1, Influence of Chlorides on the Deterioration of
Reinforced Concrete Bridge Piles or Walls, shows the method that was
used for plotting the "raw" data. On this chart it will be noted
that the structures were first segregated into average age groups of
10, 20, 30, and 40 years of service. Then a plot was made of the
condition of the structures at the particular chloride concentration
of the environment. Figure 1 shows that there is a relationship
between the chloride concentration of the environment and the dis-
tribution of the condition of structures.

INFLUENCE OF CHLORIDES ON THE DETERIORATION OF REINFORCED CONCRETE BRIDGE PILES OR WALLS

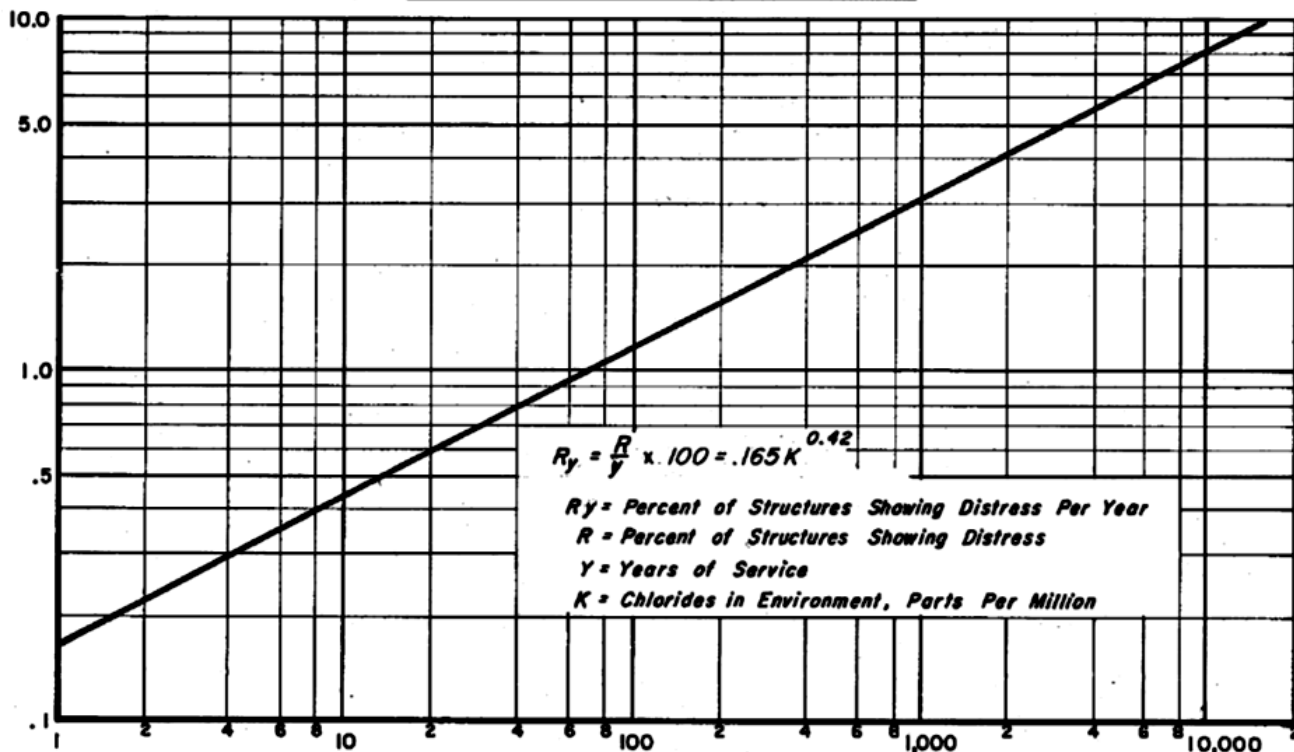
The data represented by Figure 1 were then tabulated into distribution curves of the percentage of structures deteriorated at each of the four time increments. The data were then mathematically analyzed to determine the yearly rate at which the structures would deteriorate in each chloride concentration. The result of the analysis is shown by Figure 2.

The correlation equation was found to be: Equation 1: $R_y = 0.165 \ K^{0.42}$, wherein R_y = percent of total structures showing distress per year, and K is the chloride concentration in parts per million found in either the soil or water that is in physical contact with the substructure. After the equation was derived, it was tested for its ability to duplicate the original distribution curve of the condition of the bridges.

By the method of least squares, a statistical correlation indicated that there was a correlation coefficient of 0.957 and the standard error of estimate was 7.08 percent. This indicated that the results computed by use of the derived equation were within 7.08 percent of the actual percentages of structures found to be in distress when inspected. The level of significance of the correlation is greater than 0.001.

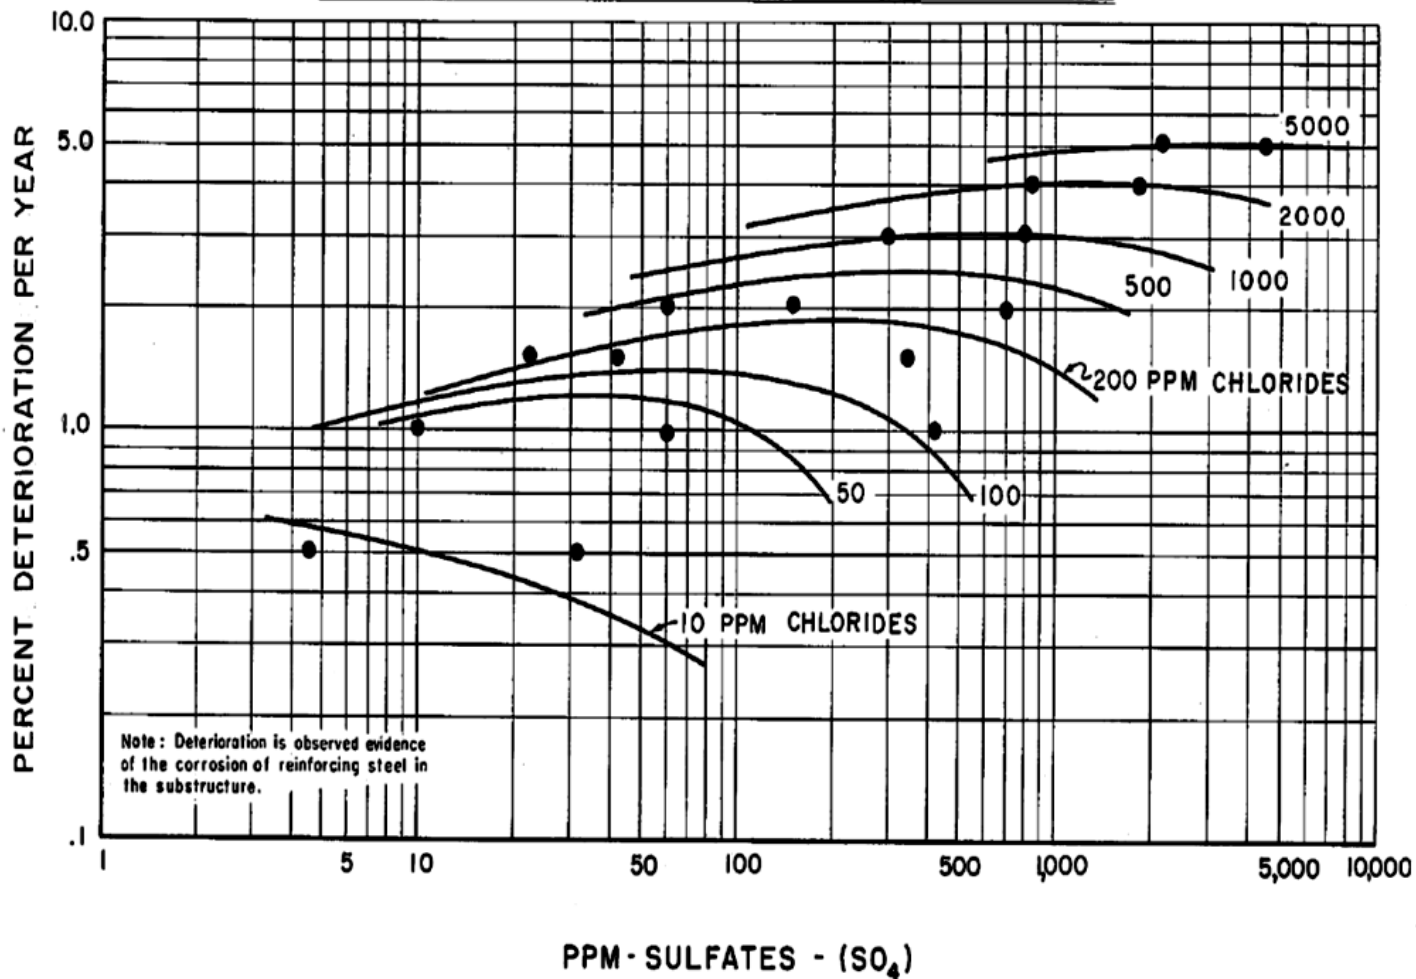
Figure 3

In order to determine the possible interdependence of the chlorides and sulfate concentration and bridge distress in the environment, the data obtained for sulfates were analyzed for a correlation to bridge conditions in the same manner as outlined for chlorides. Then the quantity of sulfates was plotted against the rate of bridge deterioration at each age group. At each of these same points of rate of bridge deterioration and age groups, the concentration of chlorides and sulfates was tabulated. The results of this comparison are shown by Figure 3, Influence of Sulfate and Chloride Concentration on Bridge Deterioration, and indicate that the more imminent cause of reinforcing steel corrosion is the chlorides present in the environment.

INFLUENCE OF SULFATE AND CHLORIDE

CONCENTRATION ON BRIDGE DETERIORATION
