Corrosão das Armaduras no Concreto Armado

Artigo resumo dos 12 artigos publicados pelo
Eng. Richard F. Stratfull - 1955 / 1976

Prof. Eduardo C. S.
Thomaz
Notas de aula

4. TITLE AND SUBTITLE
Corrosion Of Steel In Concrete

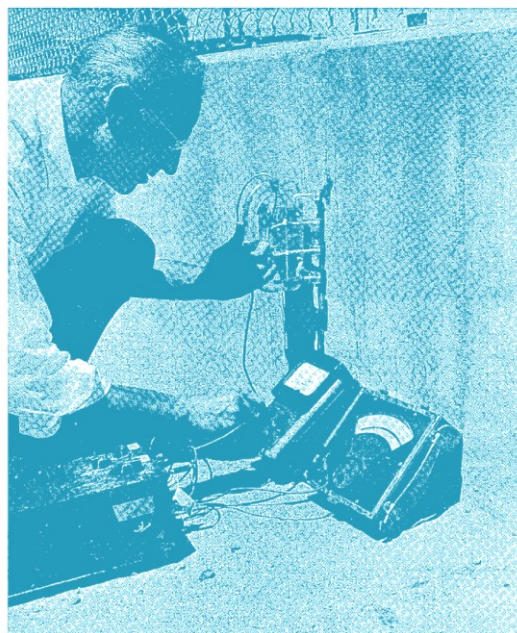
Equipamento portátil para medir a resistividade do concreto na superfície das lajes de pontes

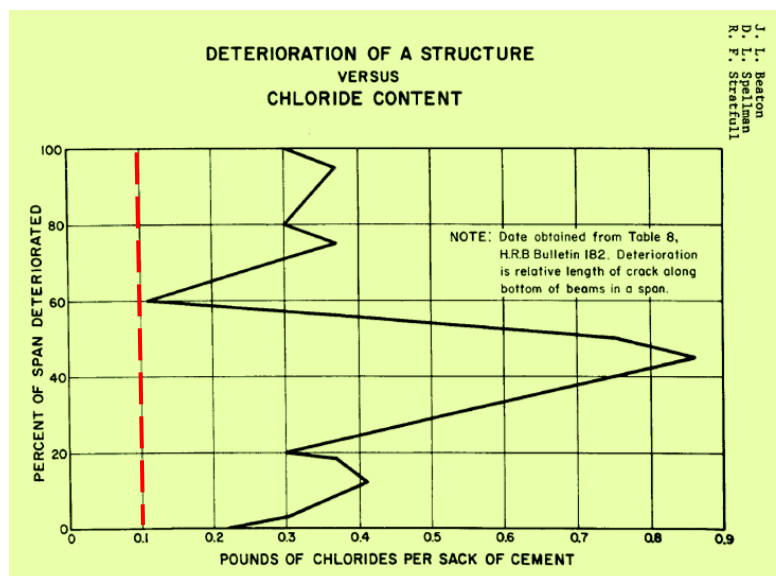
(pound / sack of cement) = 453g cloreto / 42500g cimento \approx 0,01 g de cloreto/ g de cimento = 1 %
Teor limite de cloreto para início da corrosão = 0,1 %

Não existe uma correlação entre a intensidade da corrosão e o teor de cloretos.

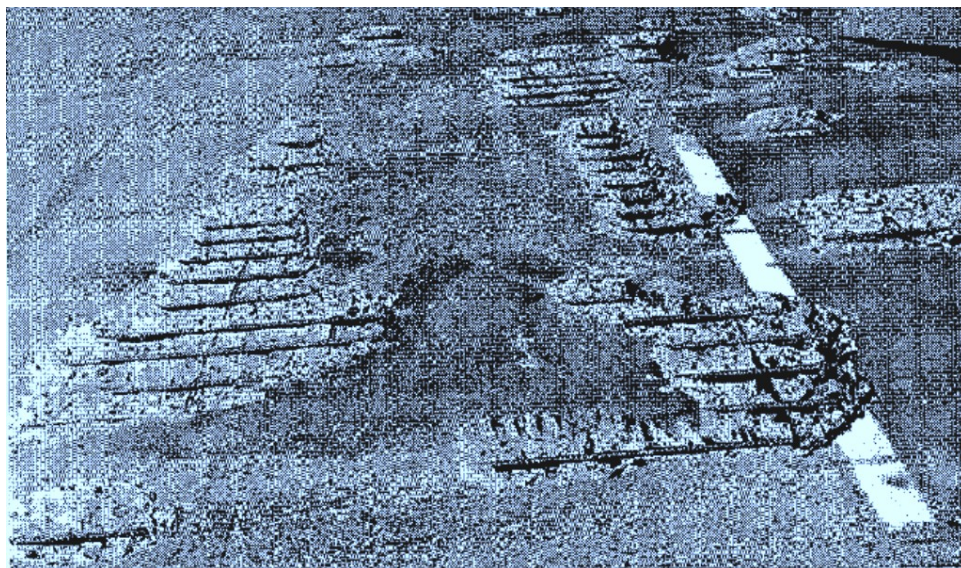
Undersurface Fractured Areas
Prepared for Patching

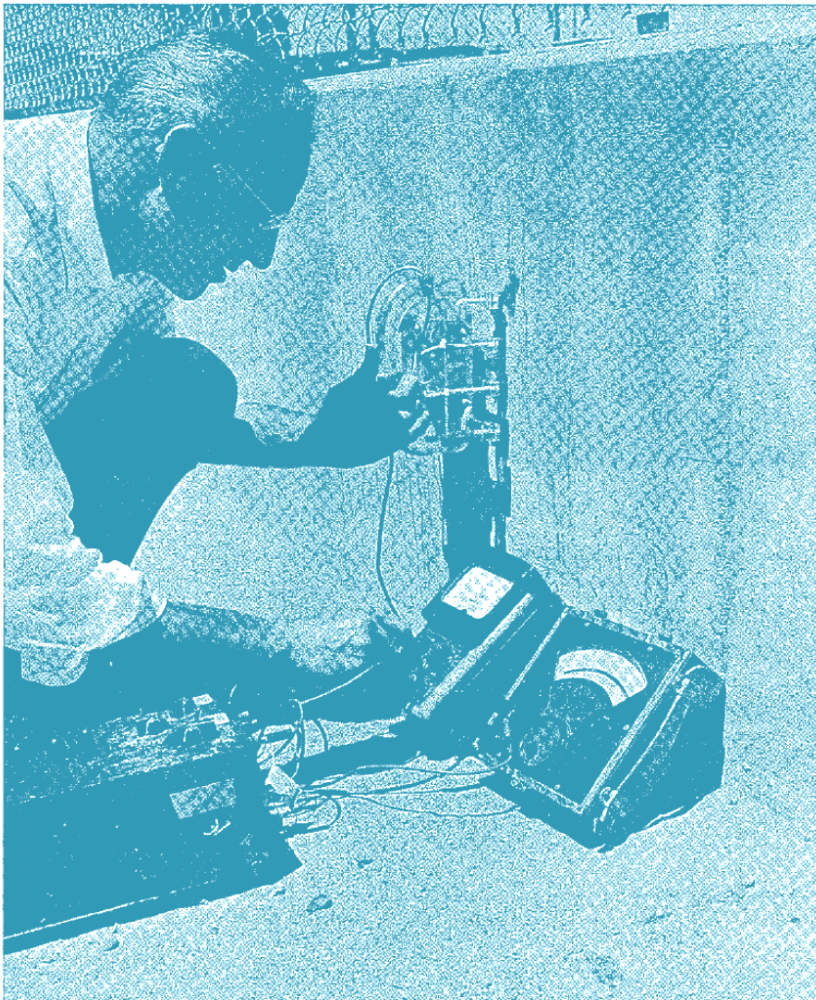
Hand-held equipment for measuring resistivity on concrete surface

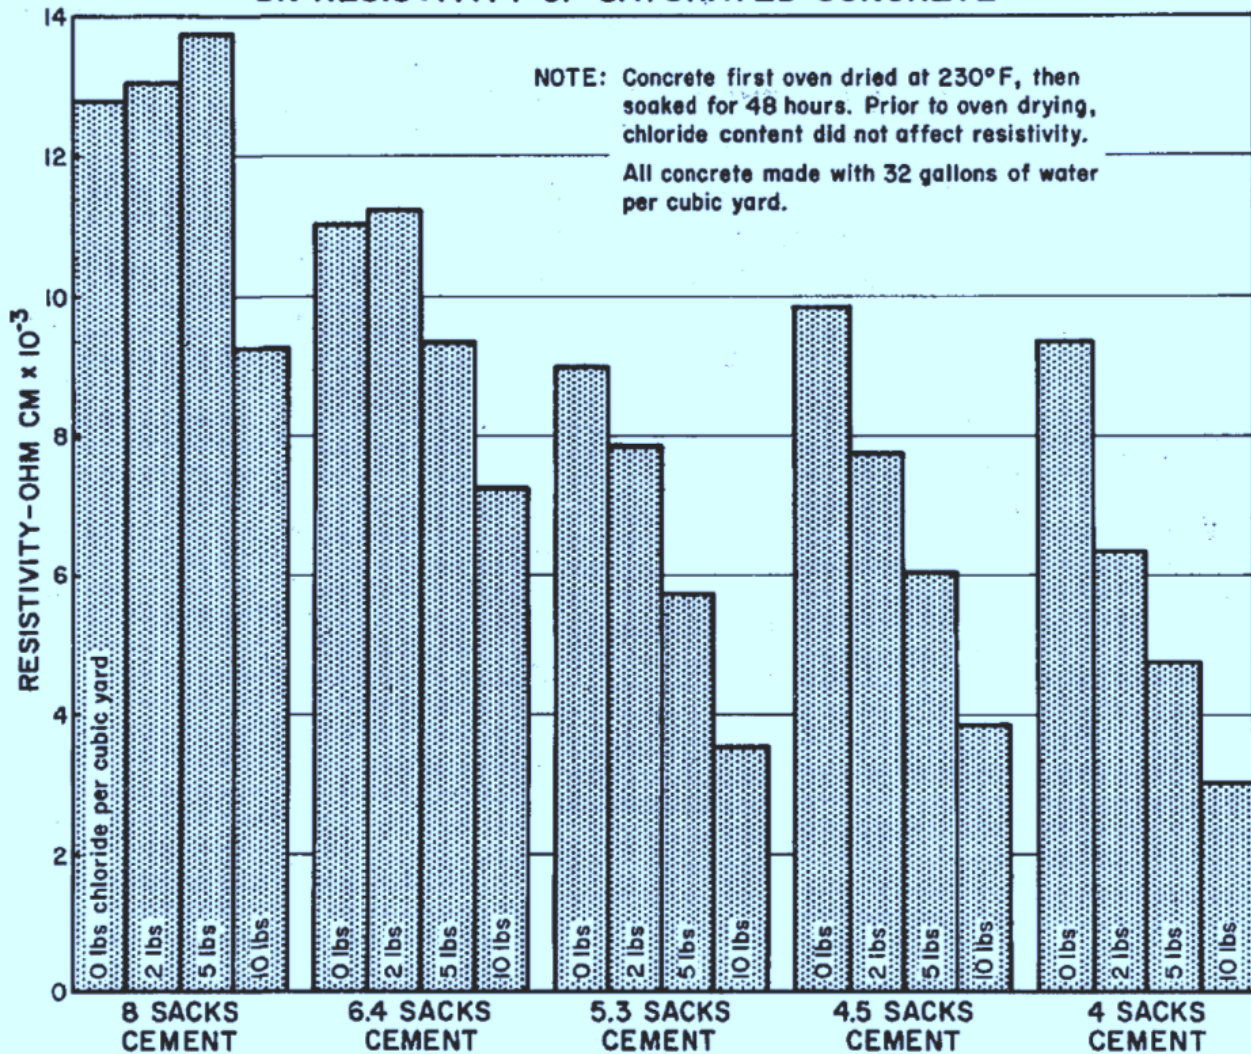
THE INFLUENCE OF MIX VARIABLES ON RESISTIVITY OF SATURATED CONCRETE

Quanto mais cimento no concreto maior a resistividade e , em consequência, menor a corrosão das armaduras.

Os cloretos reduzem a resistividade do concreto e, em consequência, aumentam a corrosão das armaduras.

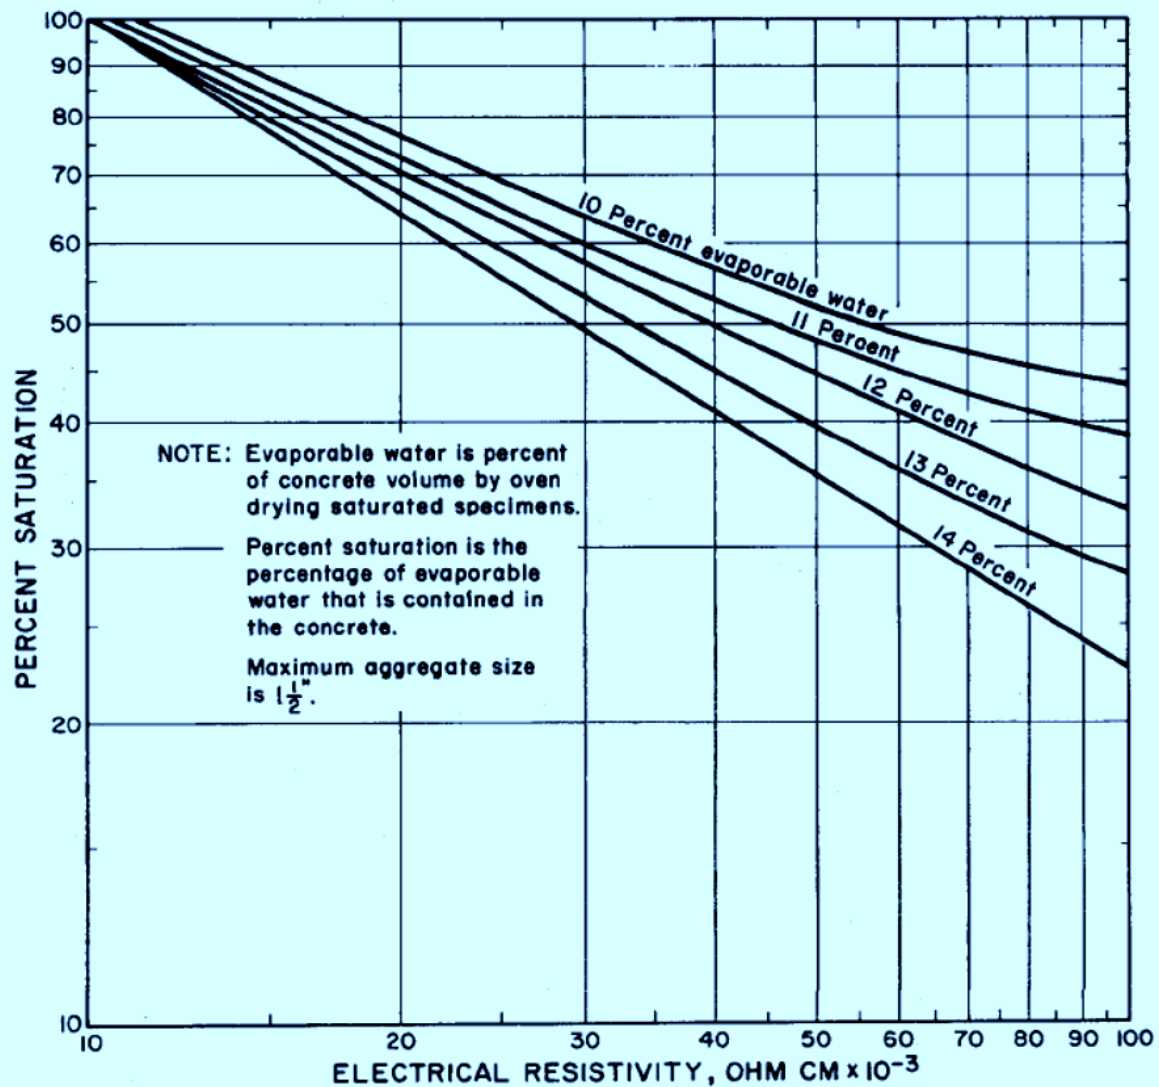
RESISTIVITY OF CONCRETE VERSUS SATURATION

Quanto mais *saturado* o concreto com água, menor a resistividade do concreto e, em consequência, maior a corrosão das armaduras.

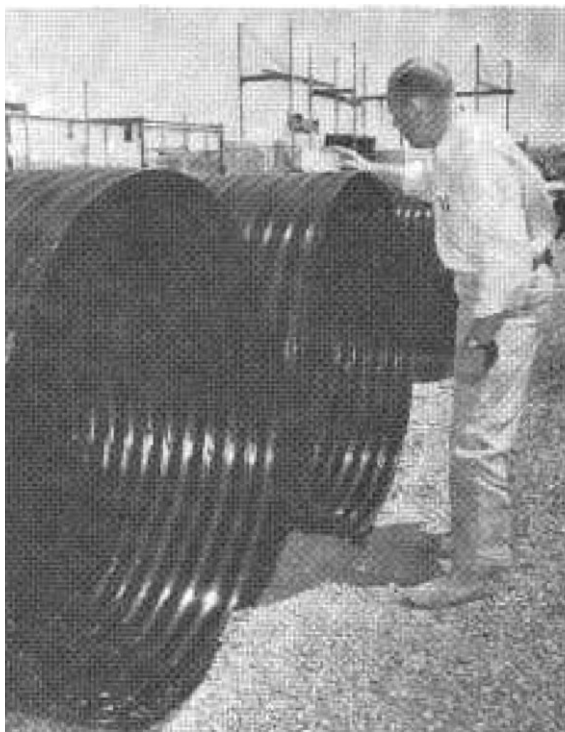
Bituminous-coated corrugated metal pipe is inspected .

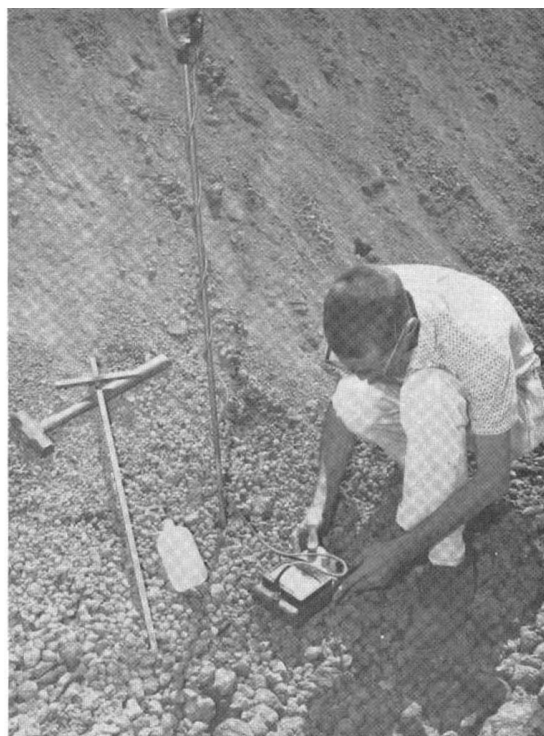
Measuring the electrical resistivity of a soil in the field .

Corrosão baixa no bueiro de aço = Resistividade alta do solo
